This modification is required in order to fit a standard UK bath waste.

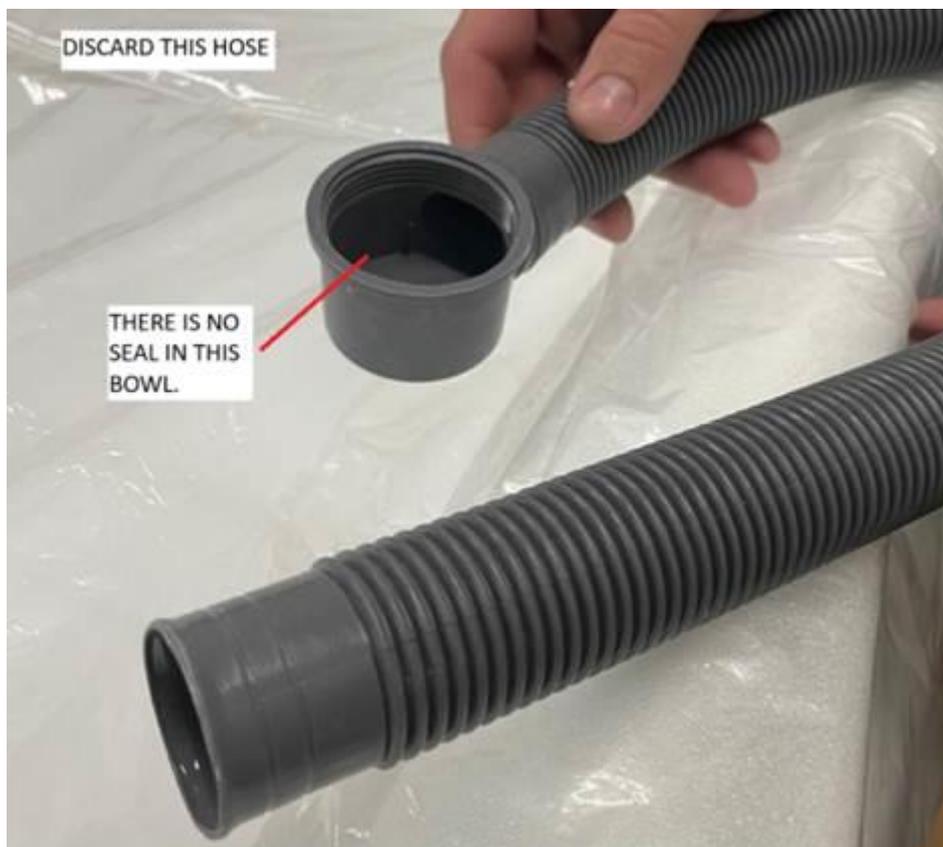
1. The waste on the Bath doesn't connect to UK fittings having a 28mm Flexible Outlet.
2. The waste body thread (where the bowl connects) isn't BSP, so a traditional trap couldn't be attached.
3. It also has a leak potential due to the absence of a seal in the hose bowl (if used).
4. Therefore, Discard this hose.

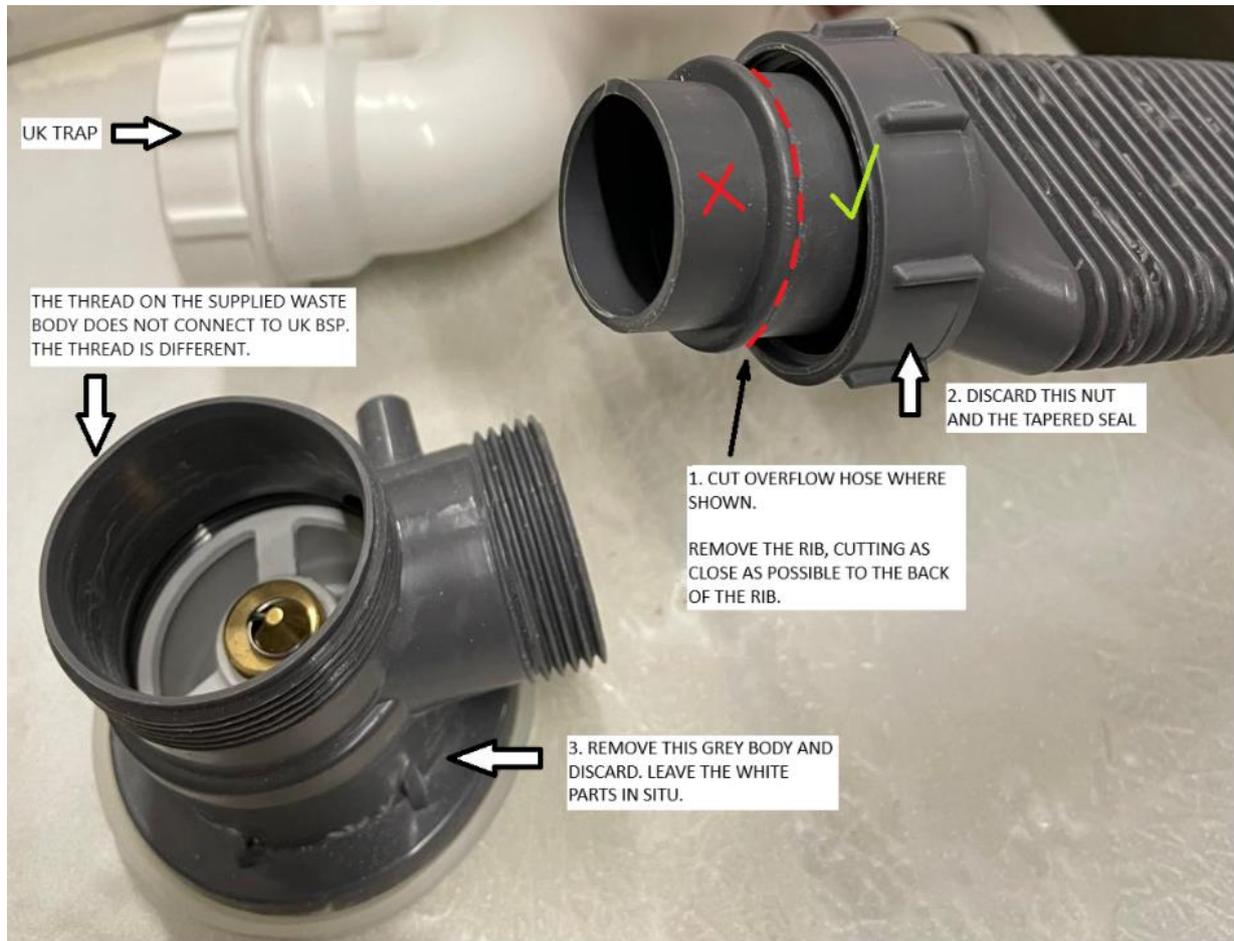
Modify the existing overflow to fit a new waste.

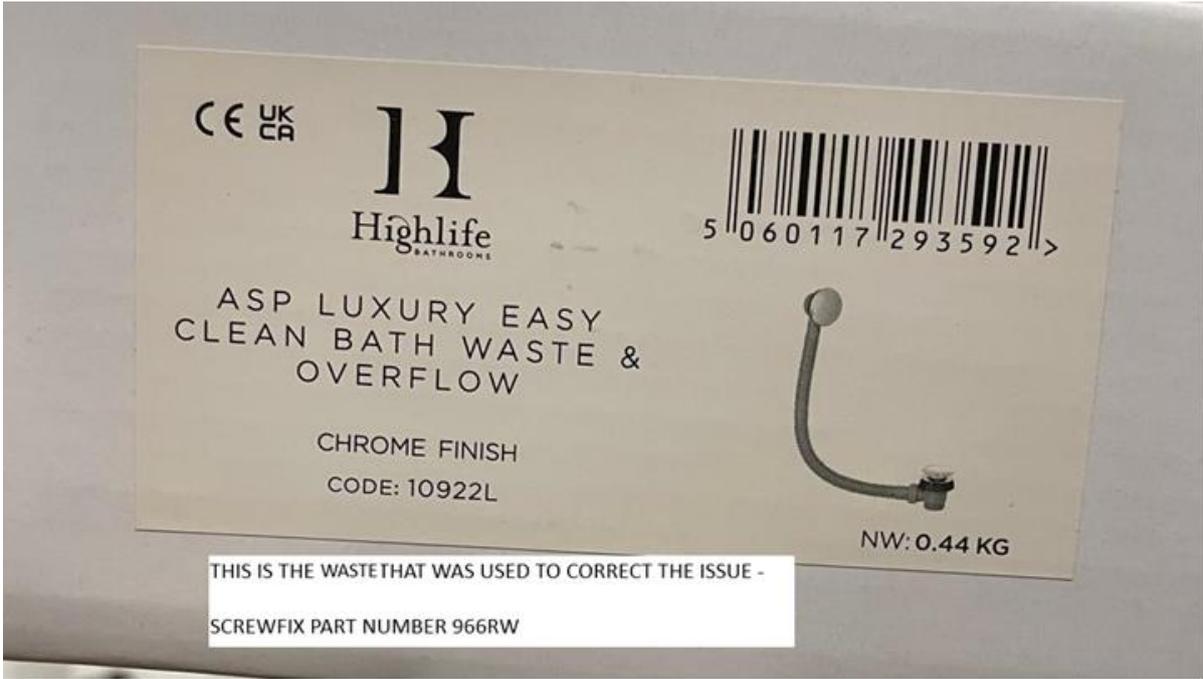
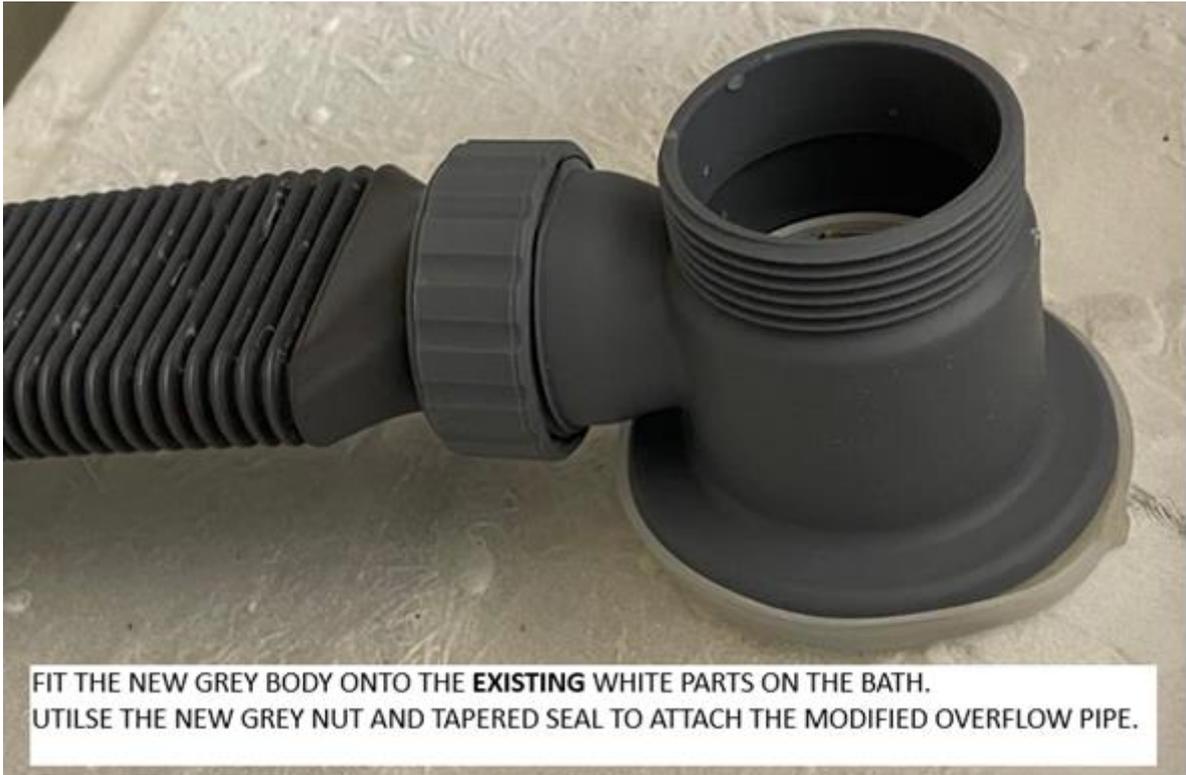
Using Screwfix 966RW - Use the parts following parts ;

Grey Waste Body – no innards

Side Nut

Side Tapered Seal

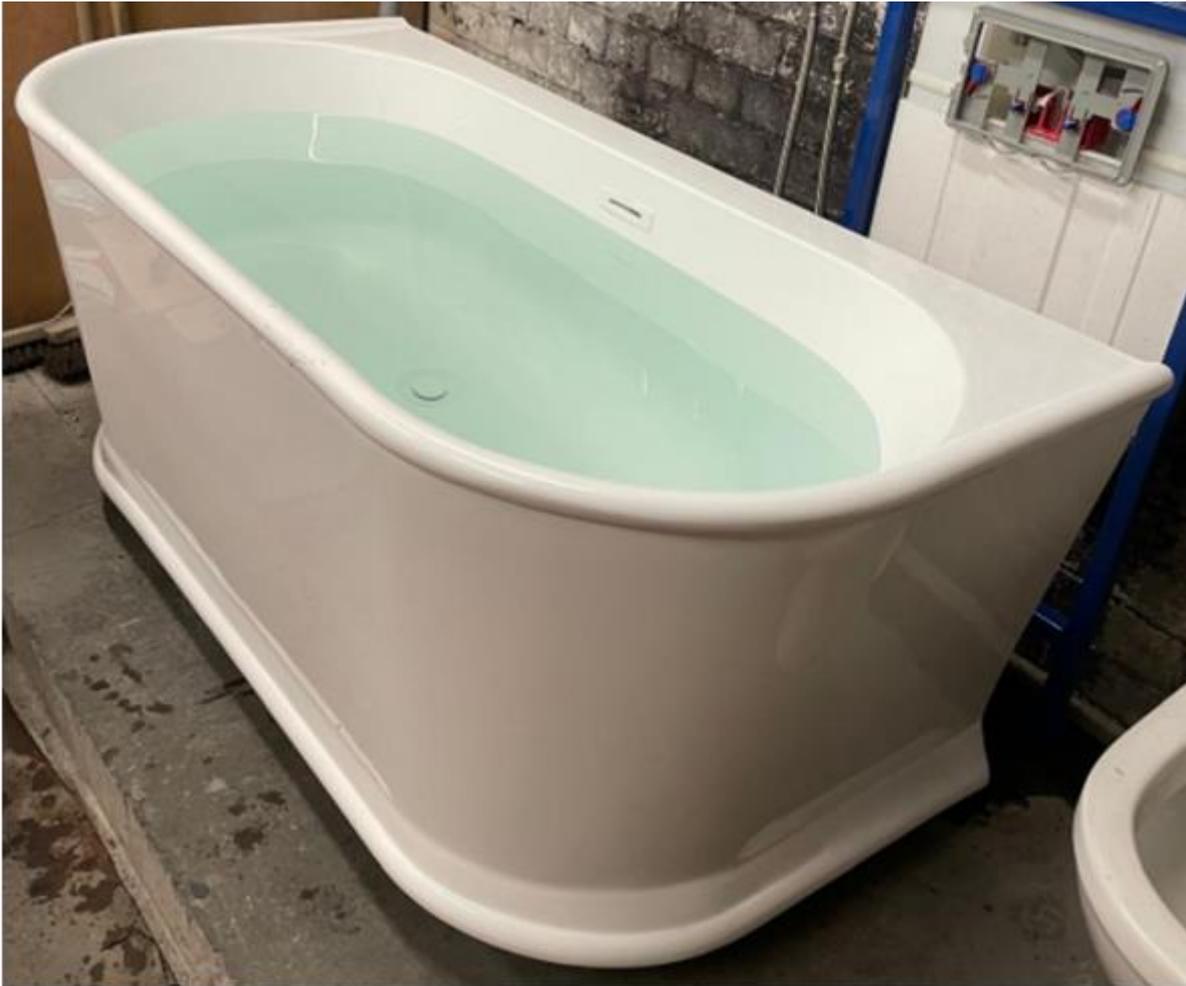
The bath was then water tested, the waste and overflow performed as expected.
